Agricultural Lands: Flooding and Levee Breaches

Abstract

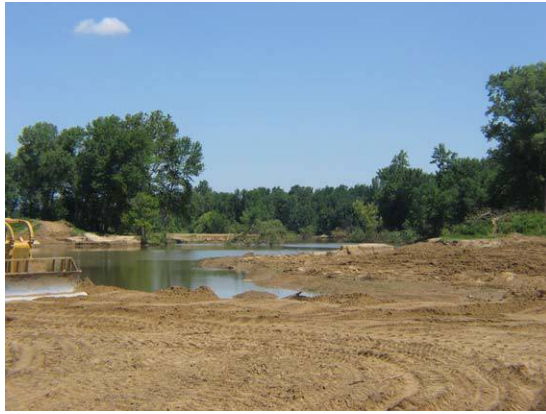
Fig. 3 Crater lake extending through 100-m levee breach.

As the floodwater tops or breaks through an earthen levee, it often drops many meters to the bottomland inside the levee and causes deep erosion of the soil and underlying geological parent material (Fig. 1). Most crater lakes (Fig. 3) are several meters deep.^[3] As the floodwater flows rapidly into the previously protected bottomland, gullies originating adjacent to the crater lake are cut into the soil and can extend 10–100 m beyond. Geologic materials, soil, sand bars, and sediment carried down river and from the degraded earthen levee are deposited in the bottomland after the floodwaters slow down (Fig. 1).^[3] The thick sand can be deposited on agricultural crops (Fig. 4) and other

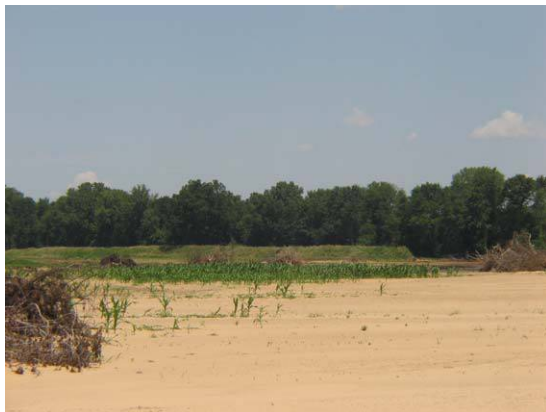
Fig. 4 Sand delta covering corn field with tree residue from between river and levee.

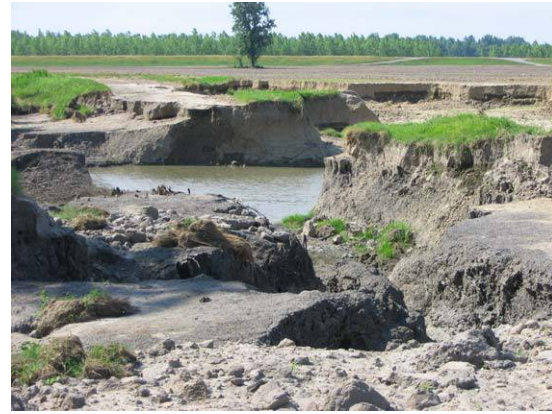
Fig. 5 Gully fields on O'Bryan Ridge with levee in background.

After a levee breach occurs and the fast current of the water has created crater lakes, extended gullies into the bottomland (Fig. 5), and scoured the land surface, the speed of the advancing floodwater begins to slow and deposit sand particles on the bottomland in large sand deltas. As the floodwaters continue to slow, the silts drop and then the clay and organic particles settle out and coat plant residues and the land surface.^[8,9] Significant land scouring can result in many hundreds of hectares of land losing centimeters of topsoil after each levee breach.
